Report No. CG-D-07-99

**Evaluating a Protocol for Testing a Fire Resistant
Oil Spill Containment Boom**

**FINAL REPORT
FEBRUARY 1999**

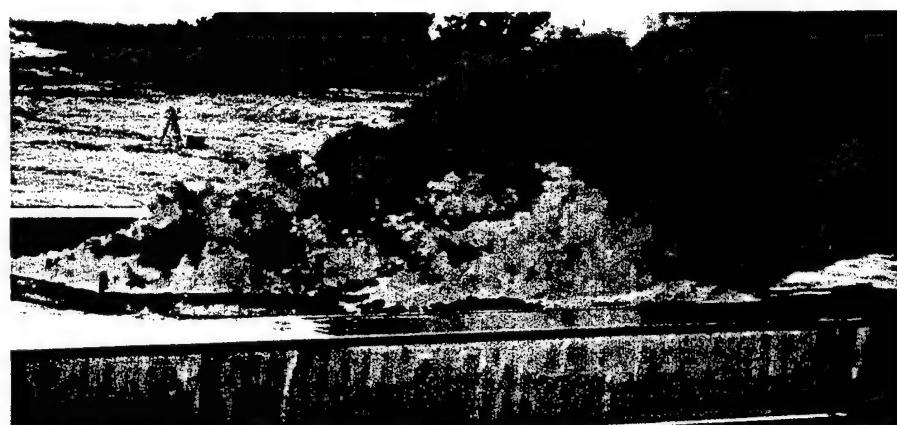
A second phenomena observed for all of the booms was intermittent burning outside of the boom. Figure 8 shows normal burning, Figure 9 shows burning beginning outside the boom, and Figure 10 shows significant burning outside of the boom. Although it might appear that oil had leaked under or through the boom, it looks as though this burning was a result of a small quantity of oil being transported over the boom by the fire. The burning outside the boom always took place in the downwind direction, even when the wind was perpendicular to the direction of wave travel. Further, burning outside the boom was observed early in the burns even though no oil was observed leaking from the boom during the initial fueling. Prior to observing burning outside the boom, oil was observed on the water surface within approximately 1 m (3.3 ft) to 2 m (6.6 ft) of the boom in the downwind direction. The flames would heat the oil outside the boom resulting in a visible vapor emission followed by ignition. After a brief period of burning, the oil outside the boom would be consumed and the fire outside the boom would self-extinguish. This process was observed periodically during the course of the one-hour burn with the burning area within a few meters of the boom.

Figure 9. Burning beginning outside boom

Figure 10. Burning outside boom

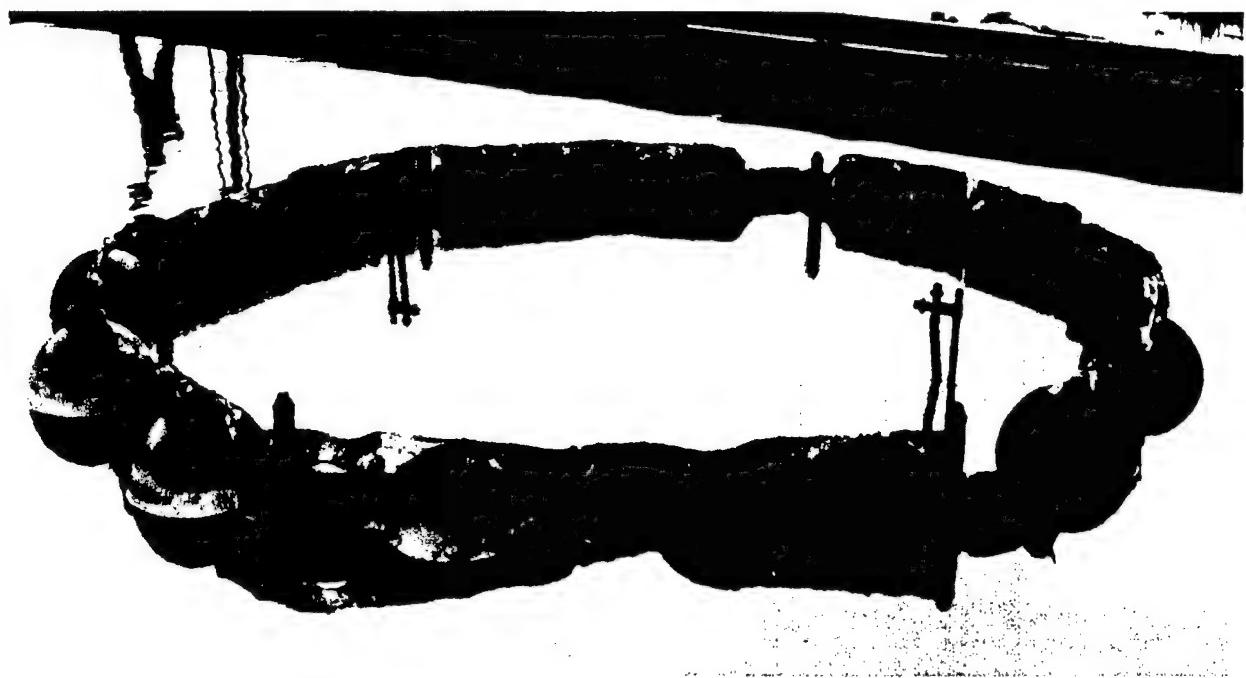
Boom	Observations	Notes
1	Degradation of the fabric coating, fabric substrate visible	Abrasion and tears in the area of the stanchions
2	Loss of sacrificial cover, some degradation of the fabric beneath the metal mesh near the joints	Small fuel leak at connector after burn 1
3	Damage to the cover and flotation in a portion of the boom, no visible change to the rest of the boom	Test terminated after the first burn when the cooling water was shut down
4	Tears and holes in the boom on the downwind side	
5	Loss of sacrificial cover, tears in the fabric along some of the coils	Abrasion and tears in the area of the stanchions - test terminated after 1 hour of burning

Figure 13. Boom 1, after burning

Figure 14. Boom 1, after burning close-up

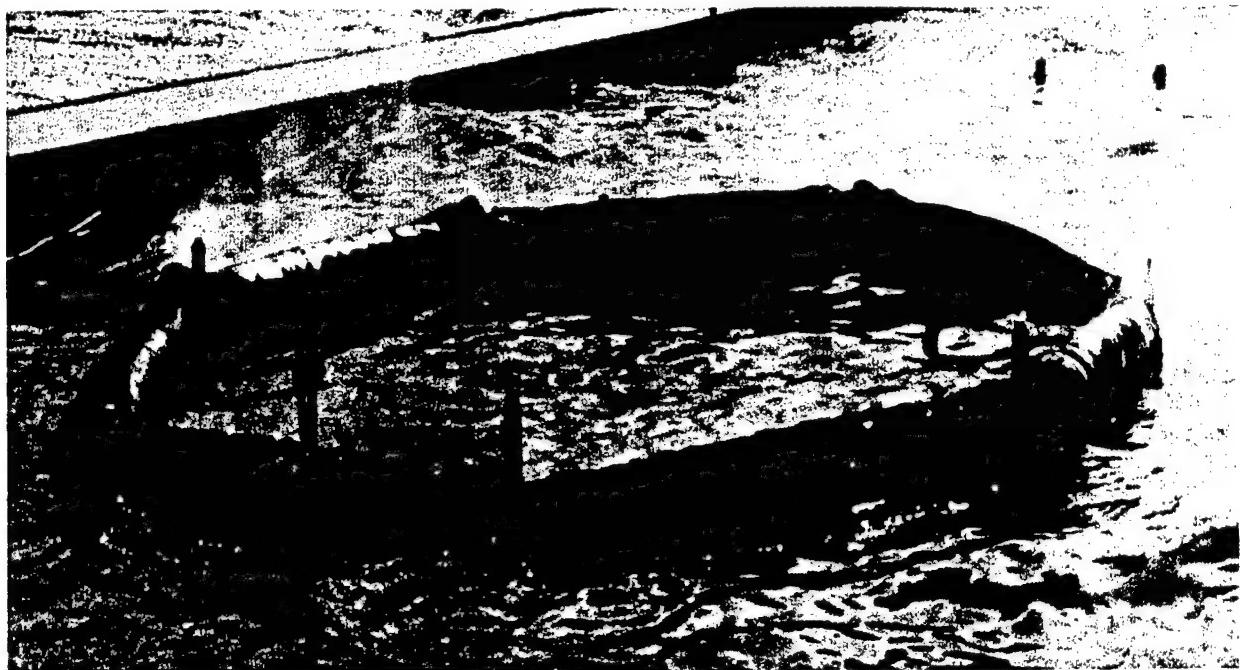
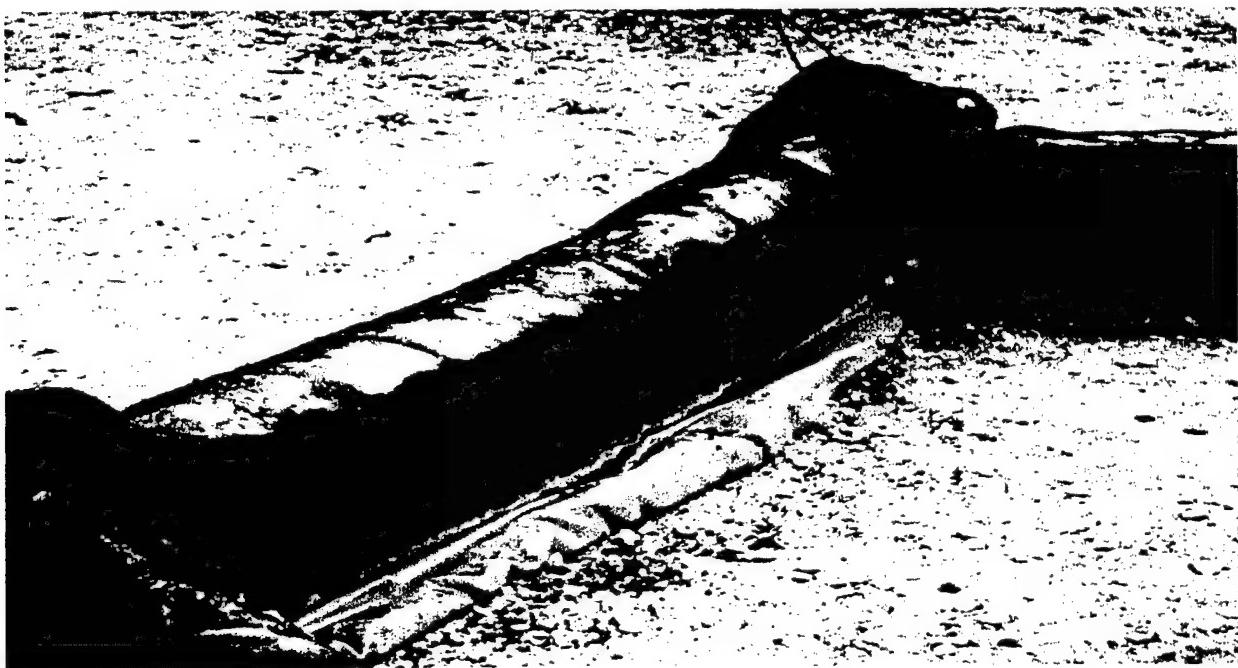
Figure 17. Boom 2, after burning

Figure 18. Boom 2, after burning close-up

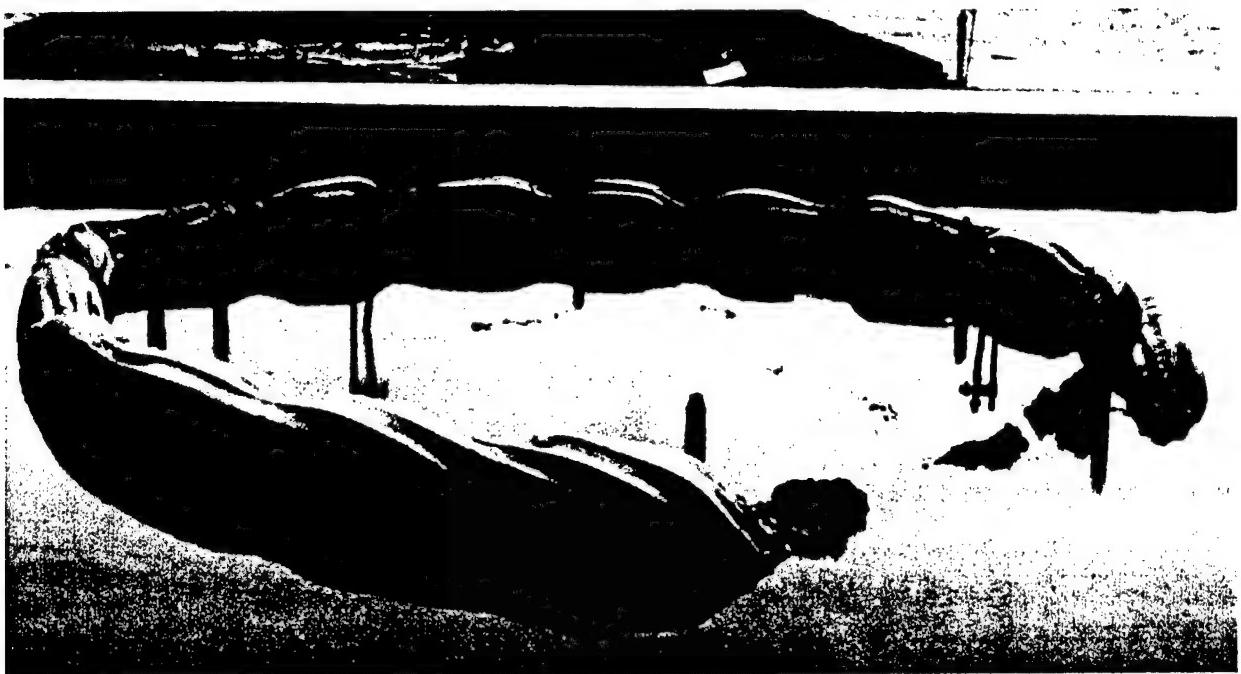
The events observed for the four non-water cooled booms followed the expected protocol. There were several issues related to the water-cooled boom 3, which resulted in differences when compared with the non-water cooled booms. During burn 1, the hose supplying water to the boom became disconnected from the boom. The loss of cooling water led to a loss of buoyancy in part of the boom on the downwind side resulting in a fuel leak and sustained burning outside the boom. Since the boom could no longer contain oil, the test was terminated. For burn 2, a new section of boom was used. Fuel was added to the boom at the same rate per unit area as for the non-water cooled booms. During the burn, it was observed that the fire appeared substantially smaller than for the non-water cooled booms. At the end of an hour the fire did not burn out, but rather, continued for a total of almost two hours. The cooling water for the boom was being drawn from a drain at the bottom of the tank. The water passed through a large filter provided by the manufacturer before entering the boom. Over the course of two hours, small rust particles in the water loaded the filter to the point where water flow to the boom was restricted. Although the fire was still burning, it was decided to shut down the cooling water and change the filter. A fire hose was used in an attempt to cool the boom, but it did not appear to be effective. Water flow was restored to the boom after approximately three minutes, but within five minutes, a part of boom on the downwind side lost buoyancy and sustained burning was observed outside the boom. This continued until the unknown quantity of remaining fuel within the boom was consumed. No third burn was conducted on boom 3.

Figure 21. Boom 3, after burning

Figure 22. Boom 3, after burning close-up

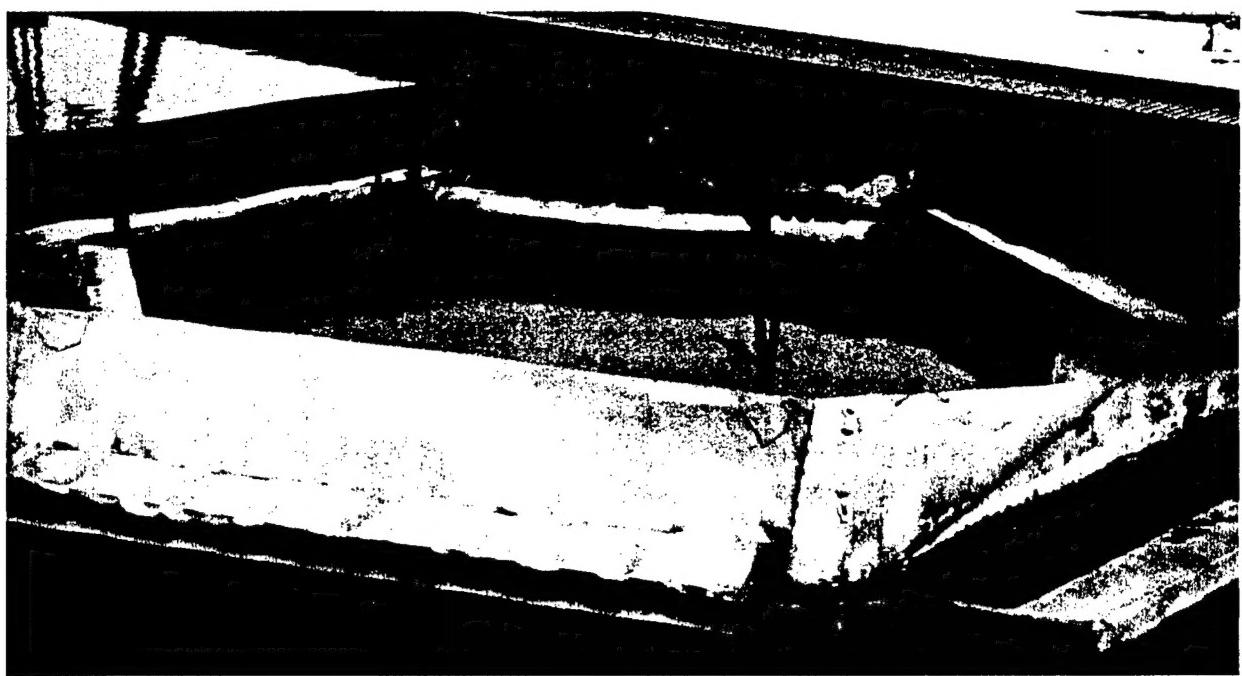
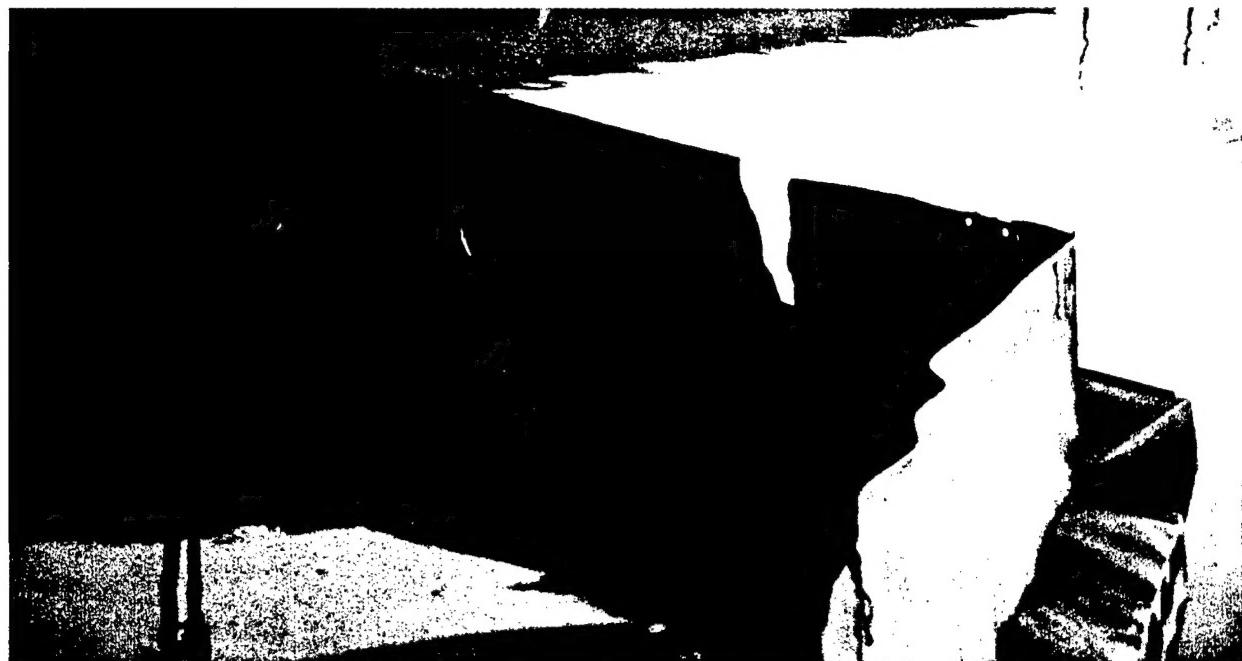
Figure 25. Boom 4, after burning

Figure 26. Boom 4, after burning close-up

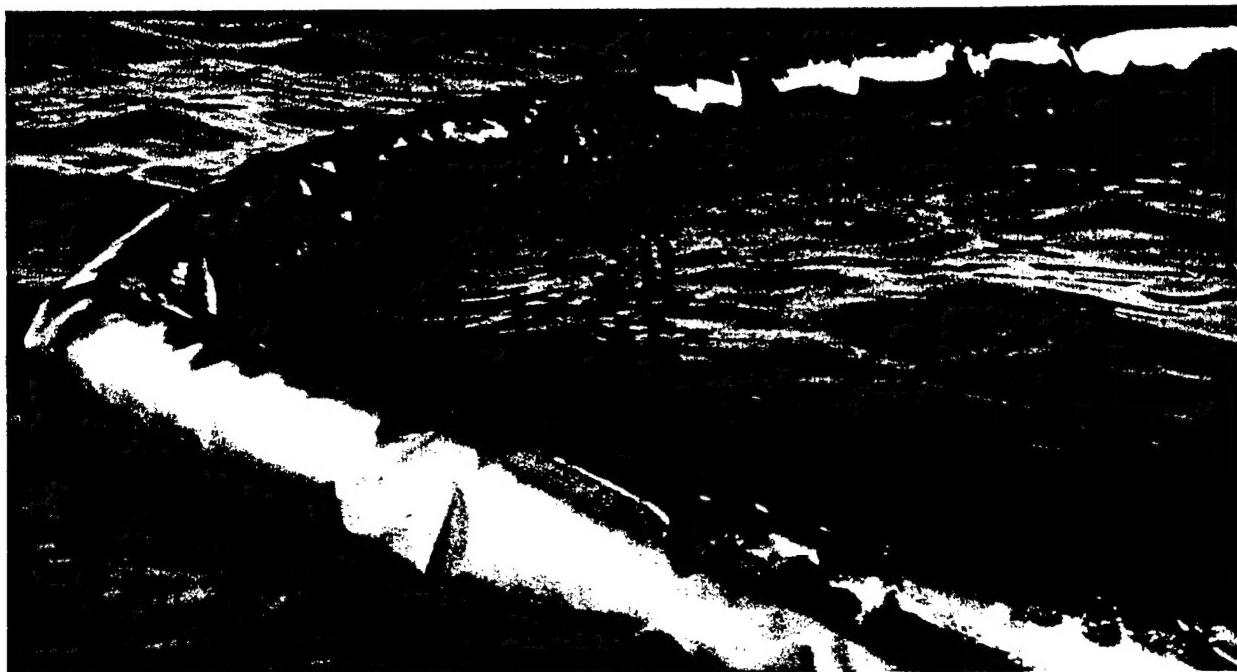
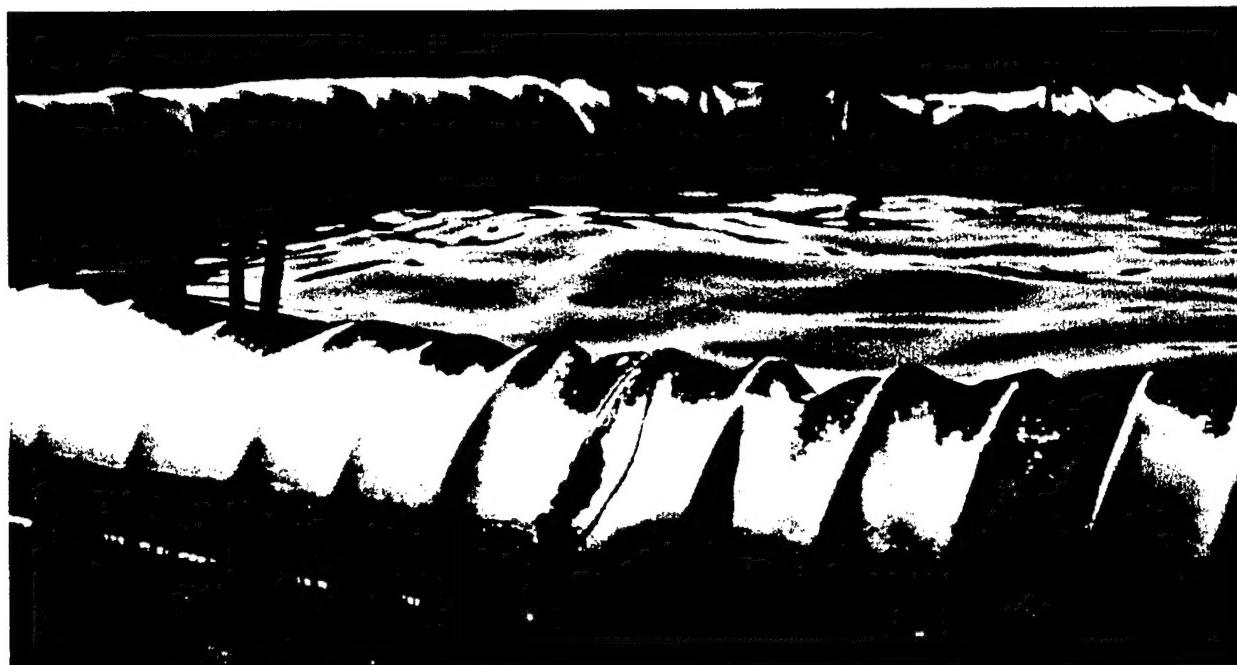
Figure 29. Boom 5, after burning

Figure 30. Boom 5, after burning close-up
